# **Development of a Remote External Repair Tool for Damaged or Defective Polyethylene (PE) Pipe**

## **Final Report**

February 2007

Submitted by:  
Timberline Tool  
2594 Montana Highway 35  
Kalispell, MT 59901

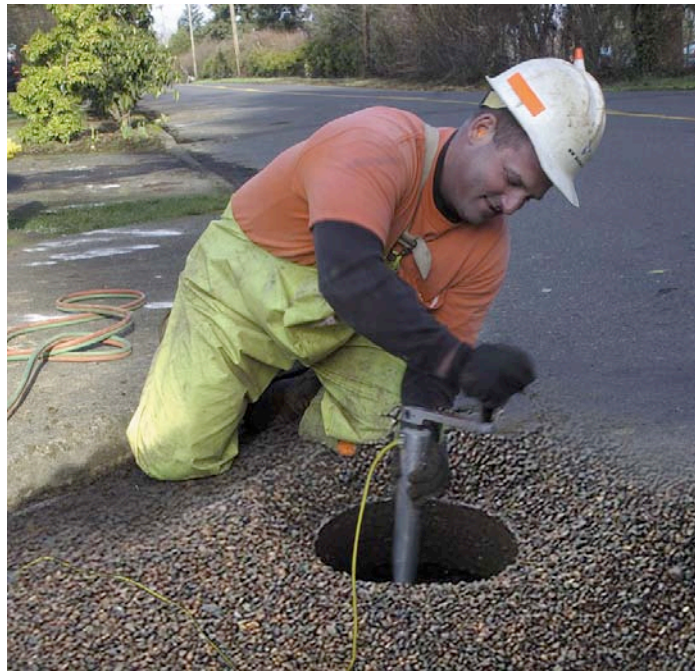
**Figure 1: Keyhole excavation**

The portable and lightweight repair tool developed in this project operates from the top-down, without the need to fasten the device under the pipe. This dramatically improves the safety and repair procedures because one person conducts a single repair operation and a single excavation. It operates in difficult and keyhole access situations (Figure 1) without the need for pipe squeeze-off.

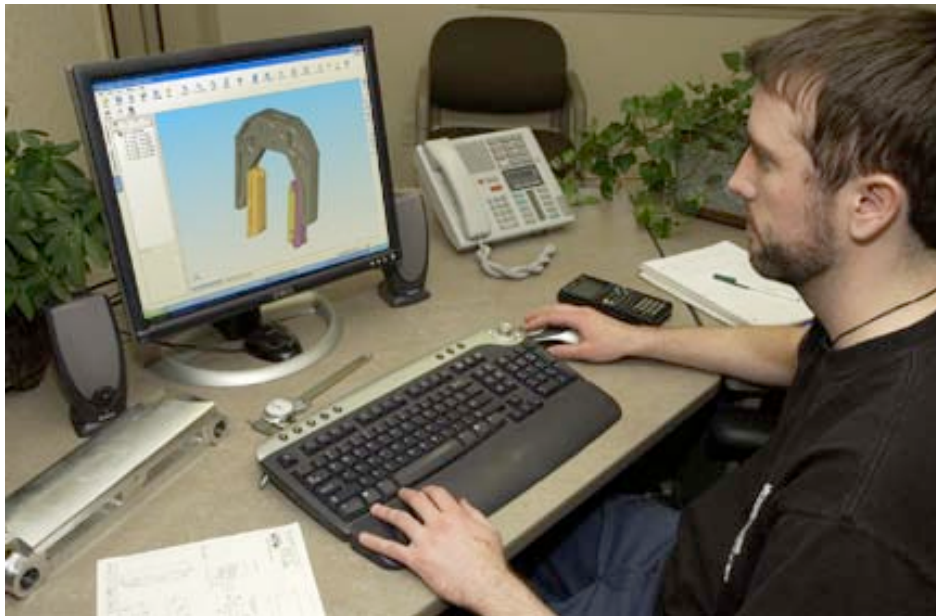
Three mechanical tool configurations were designed. Work included SolidWorks® 3D modeling the optimum design (Figure 2) to ensure remote operation, keyhole application, and compliance with natural gas industry operating practices<sup>6</sup>.

**Figure 2: SolidWorks® 3D modeling of the mechanical tool design**

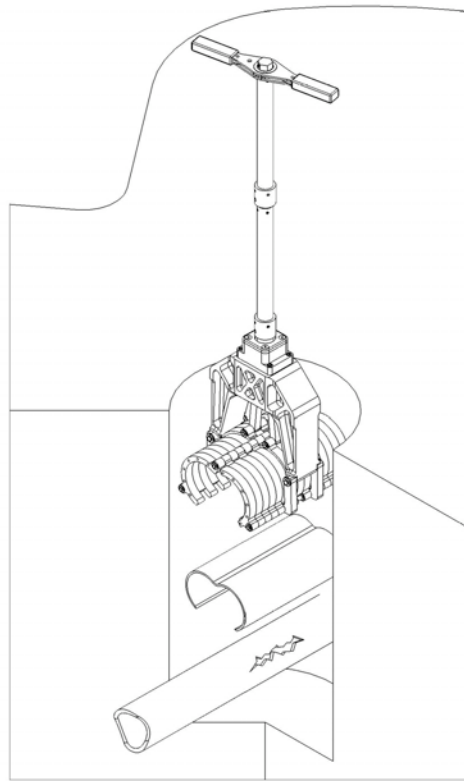
The optimum design concept was chosen and a test tool developed and tested to determine functionality, safety and reliability (Figure 3). In-house laboratory testing was performed to determine safe and effective operation of the test tool. No ASTM standards currently exist for the testing of the repair tool. It was agreed, however, that the tool would be tested per ASTM F1563 (Standard Specification for Tools to Squeeze-off Polyethylene (PE) Gas Pipe or Tubing).

***Figure 3: Final Test Tool Design***

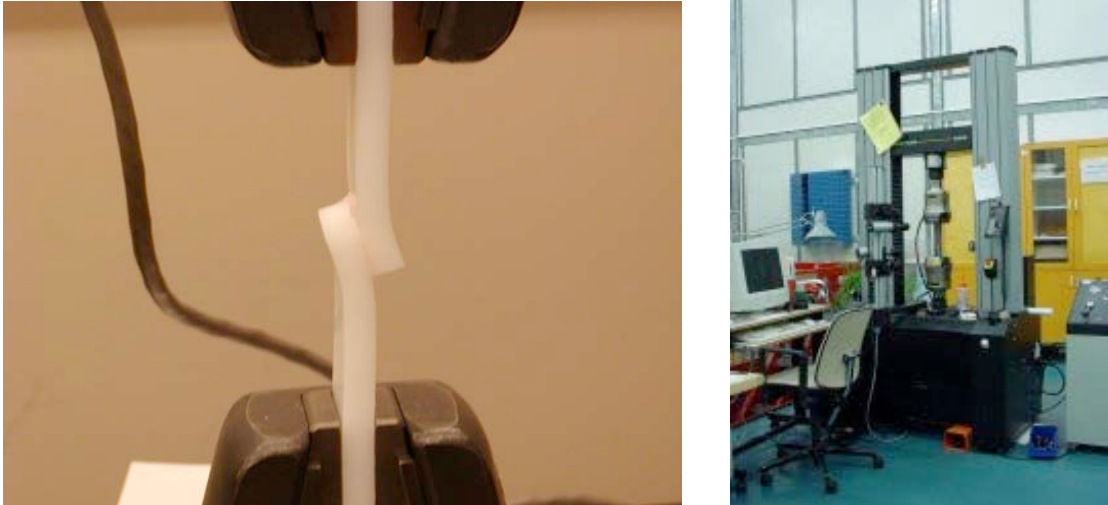
2. PE adhesives: This method utilized structural plastic glues to join the surfaces of the PE patch and the damaged PE pipe. This phase of the research focused on finding an adhesive to bond PE to PE natural gas pipe, which would withstand at least 500 psi (as with the gel concept above). Although many different adhesives were considered, the investigation focused on three structural plastic glues (3M DP8005, 3M DP8010 and Loctite 3030). Glue strength was tested on all three glues with an overlap shear test using an Instron machine (Figure 4).

**Figure 4: Overlap shear test using an Instron machine**

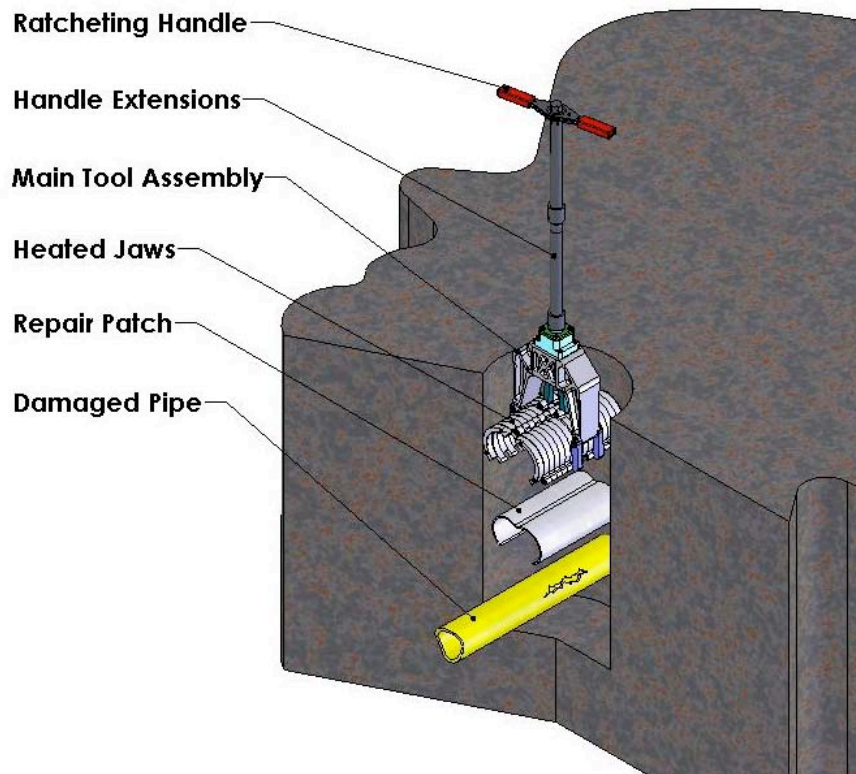
Information from Phase 1 was used to guide the final design of the engineer prototype and the repair patch (Figure 5).

**Figure 5: Final design of the engineer prototype for PE pipe repair**

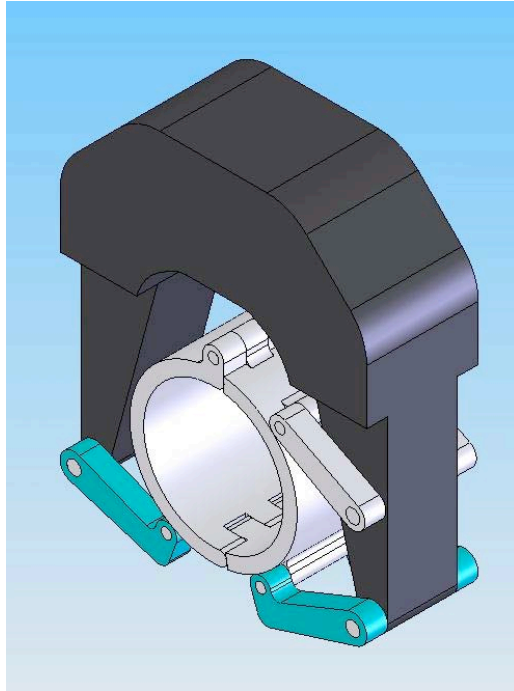
**Figure 8: Repair tool design concept 1**

CAD Concept 1: In the first CAD concept (Figure 8), solid jaws were incorporated and manipulated by three linkage points. Solid jaws were beneficial in applying constant controlled pressure, but were not favorable for work on more than one pipe size. In order for the tool to apply pressure to the repair patch, a constant downward force and/or the use of loaded springs or cylinders was required. This concept had an asymmetrical closure on the pipe, which could present problems when used in keyhole excavations.

This project was performed in two Phases. During Phase 1, various conceptual designs were developed for the mechanical tool to apply the thermo-chemical patch to the compromised area on the PE pipe (Figures 8, 9 & 10). A preferred mechanical tool and repair patch design were selected and laboratory tests (quick-burst tests and sustained pressure tests) were performed on repaired PE pipe sections to determine the overall performance of the test tool, and the quality and adequacy of the repair procedure. In Phase 2, information gained in Phase 1 was used to continue the research on the thermo-chemical repair patch and construct two engineer prototypes. Laboratory tests were performed on repaired PE pipe sections using the same testing protocol and procedures as Phase 1. Specific results and progress are discussed under each task listed below.

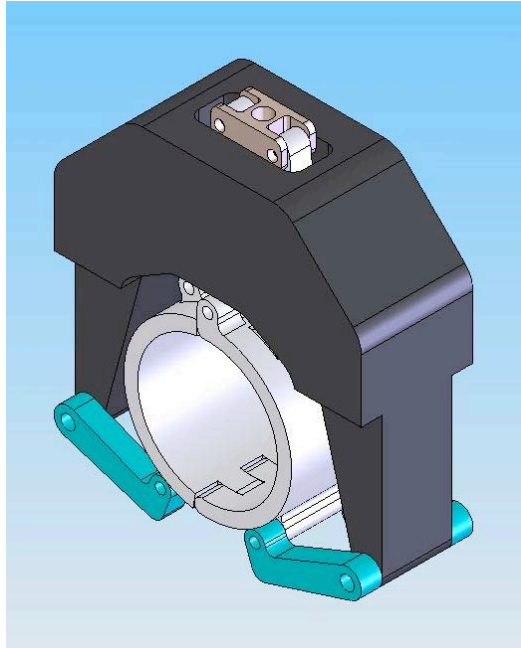
**Figure 9: Repair tool design concept 2**

CAD Concept 2: Similar to CAD Concept 1, this concept (Figure 9) had solid jaws. Four linkage points were needed to open and close the jaws. Closure was controlled mechanically by turning a drive thread. This concept provided symmetrical closure on the pipe making it more advantageous than Concept 1, especially for use in keyhole excavations.

Concept 2 was chosen for further investigation because it provided several advantages over the other concepts. It was relatively easy to manufacture since it had few moving parts. The jaws were solid and had four linkage points on each jaw. This tool design applied uniform pressure to the patch and had an easily controlled mechanical closure.

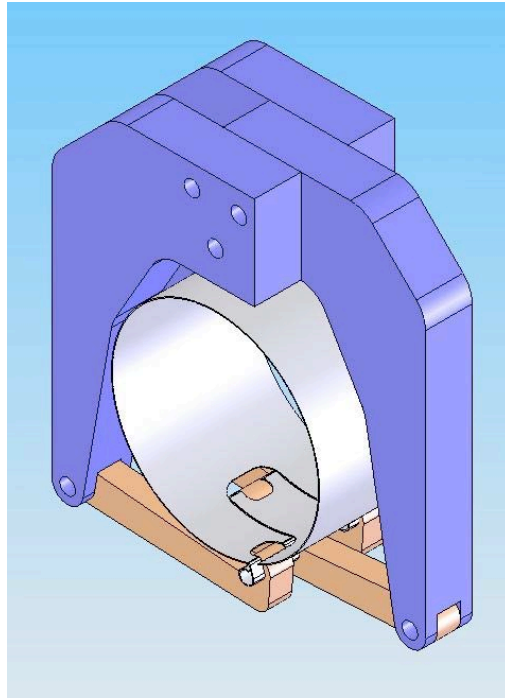
CAD Concept 3: This concept (Figure 10) differed from the other two CAD concepts by utilizing a flexible jaw made from either spring steel or a band heater. Three linkage points wrapped the jaw around the pipe, and with downward force and/or loaded springs applied pressure to the patch. However, the jaw closure did not exhibit as much control as CAD Concept 1 or 2.

**Figure 10: Repair tool design concept 3**

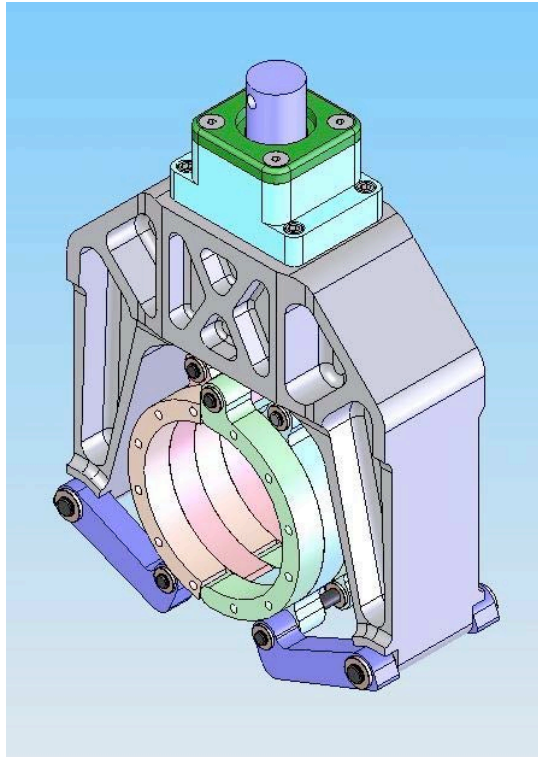
**Figure 11: Final test tool design**

The technical objective of this subtask was to refine the design selected for implementation in Subtask 3.2, and to create engineered drawings needed to manufacture the test tool. The design of the tool (Figure 11) was refined utilizing FEA and CAD, with the following enhancements made to the final tool:

- The dynamics of the tool were reviewed and verified.
- Mechanical stops were added to insure the reliability of the tool.
- The weight of the tool was minimized while ensuring structural integrity.
- The design was reviewed to ensure suitability for manufacturing.
- The jaws were redesigned as layered components and cut using the water jet method to simplify the production process.
- The jaw design was improved to accommodate cartridge heaters and a thermocouple.

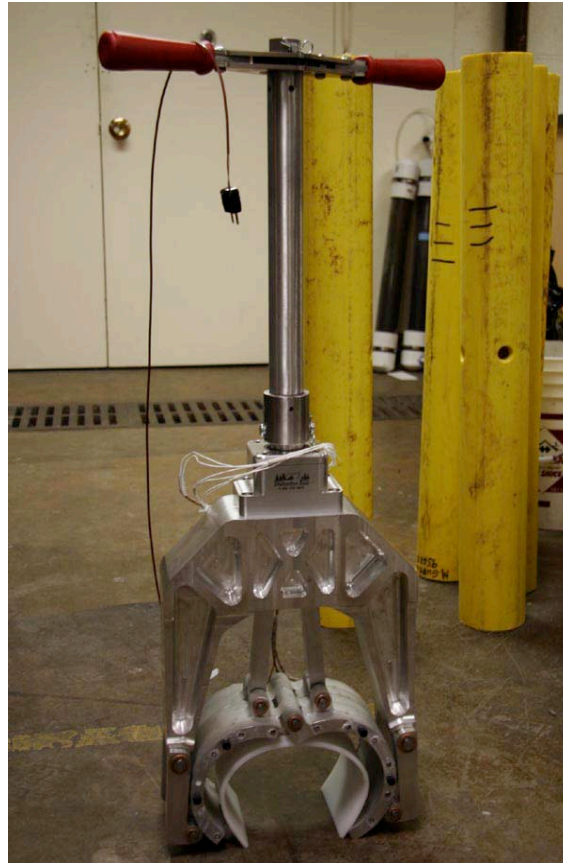
**Figure 12: Final test tool with repair patch**

The preferred design was transferred from SolidWorks® to Computer Aided Machining (CAM) software for virtual machining of each part. The CAM software output a program to manufacture each tool component using Computer Numerically Controlled (CNC) machining centers (Figure 12 ). The test tool was assembled (Figure 10) based on the engineer drawings presented in Subtask 3.3. A majority of the mechanical components were fabricated from 6061-T6 aluminum. In-house testing was performed to determine safe and effective operation of the test tool.

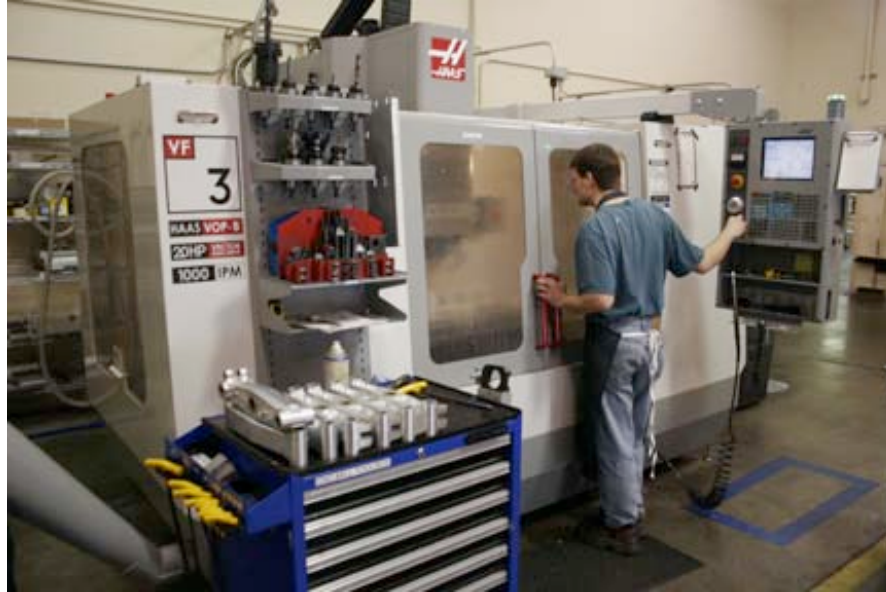
**Figure 13: Computer numerically controlled (CNC) machining center**

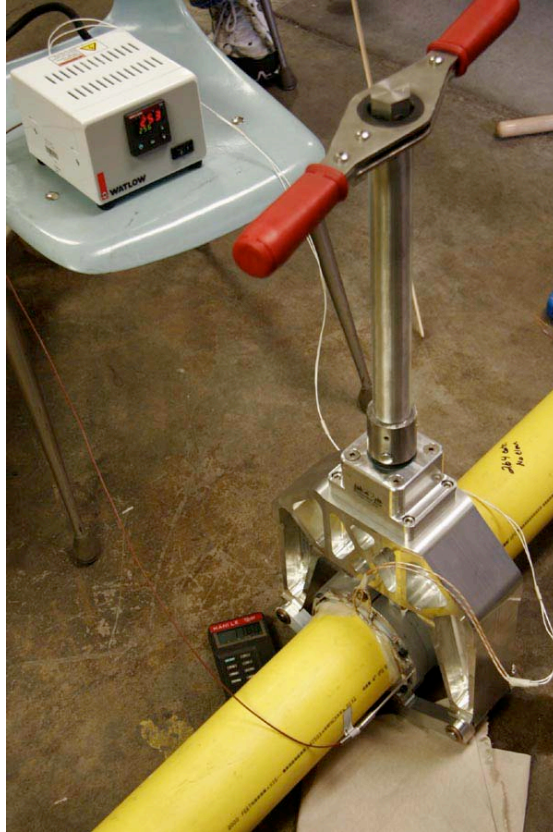
The mechanical design proved successful (Figure 14) during initial functionality testing. A 1-inch hole was drilled into the pipe wall of a 3 ft section of 4-inch IPS SDR 11.5 MDPE pipe to simulate damage produced by a large gouge. This pipe section was used to test the ability of the test tool to successfully apply a thermo-chemical patch over the simulated damage. Little effort was required to fully wrap the PE gel film patch around the damaged area of the pipe. The tool applied adequate constant pressure to the patch. The internally heated (cartridge heaters) jaws heated rapidly and held the temperature at  $\sim 125^{\circ}\text{C}$ . The repair process was completed in 90 minutes. The initial repaired pipe sample was able to withstand  $> 450$  psig of hydraulic pressure during a quick burst test.

*Figure 14: The test tool in the process of applying a repair patch*

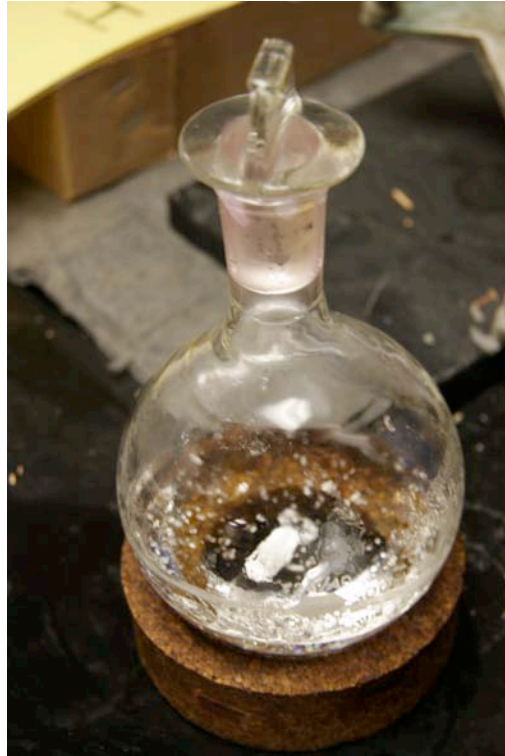
**Figure 15: UHMWPE powder dissolved in heated solvent**

PE gels were researched as a method for adhering PE to PE once the peak strength of the DP8010 was determined. The PE gel produced in this project consisted of an Ultra High Molecular Weight PE (UHMWPE) powder dissolved into a solvent (Figure 15). Then the resulting mixture was pressed into a sheet (Figure 16) that consisted of approximately 3-8% of PE (93-98% solvent). This pressed sheet was then dried (Figure 17) to an approximate solvent concentration of 10-20%.

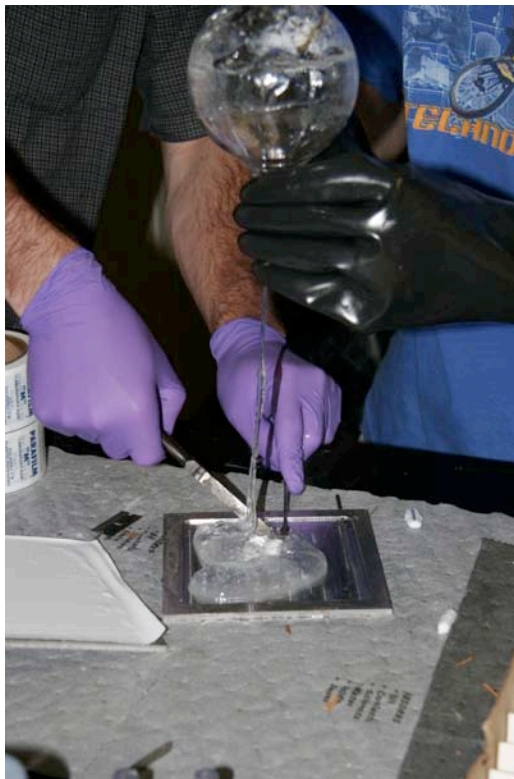
**Figure 16: Dissolved UHMWPE pressed into a sheet**

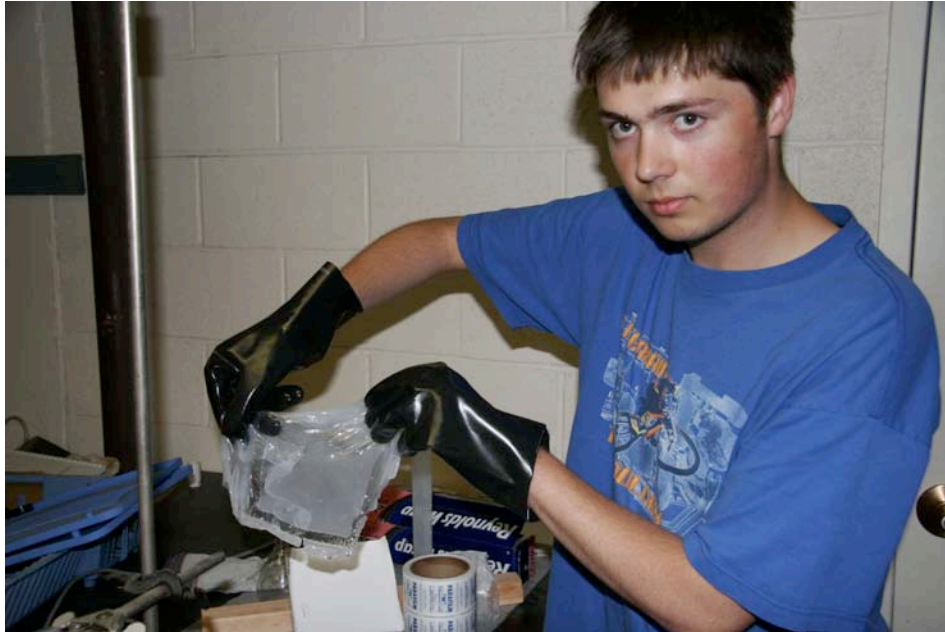
**Figure 17: Pressed sheet**

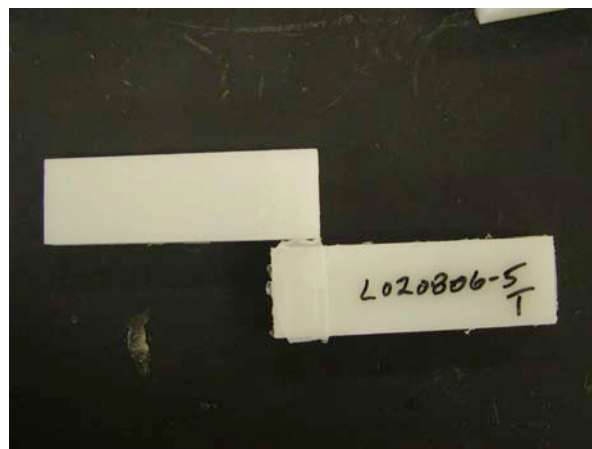
Subsequently, the UHMWPE gel sheet was cut into strips and sandwiched between two pieces of HDPE substrate (Figure 18). The HDPE substrates were bonded using the PE gel in a Carver press (Figure 19) equipped with heated platens. Various scenarios of the lap shear tests were performed varying the test sample thicknesses, pressure of application, and temperature of the platens. All the samples were prepared using a modified version of the ASTM standards D3163, D3165, and D5868.

**Figure 18: UHMWPE gel sheet prior to being sandwiched between HDPE substrates**

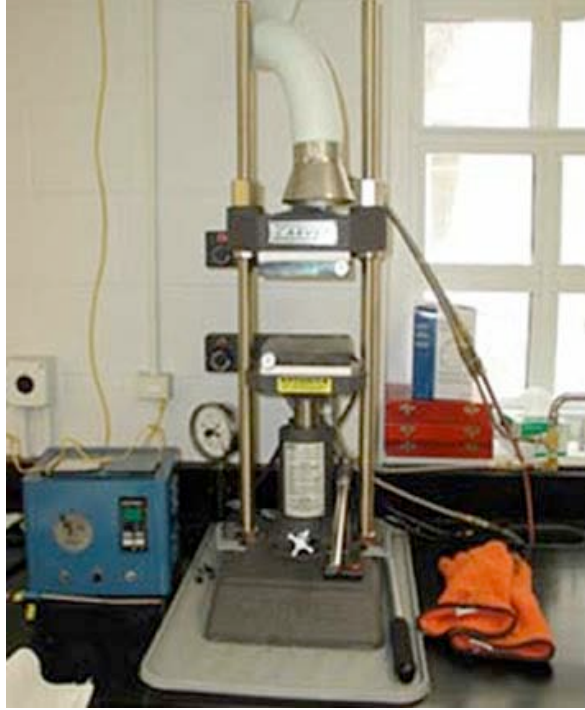
**Figure 19: Carver press equipped with heated platens**

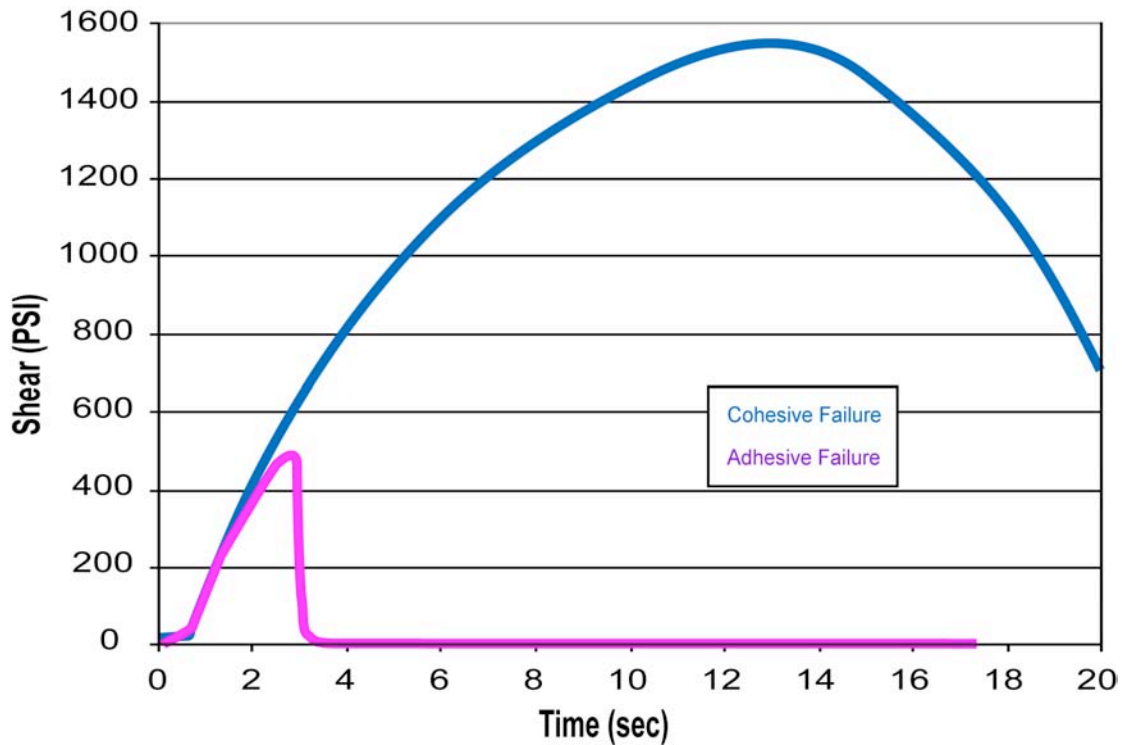
When these PE gel lap shears were tested in an Instron, they exhibited cohesive failures (i.e., the substrate (PE) failed) as opposed to the adhesive failures seen with the DP8010 bonds. A graph showing adhesive vs. cohesive failures during a lap shear test is shown in Figure 20.

**Figure 20: Graph of cohesive vs. adhesive failures during lap shear tests**

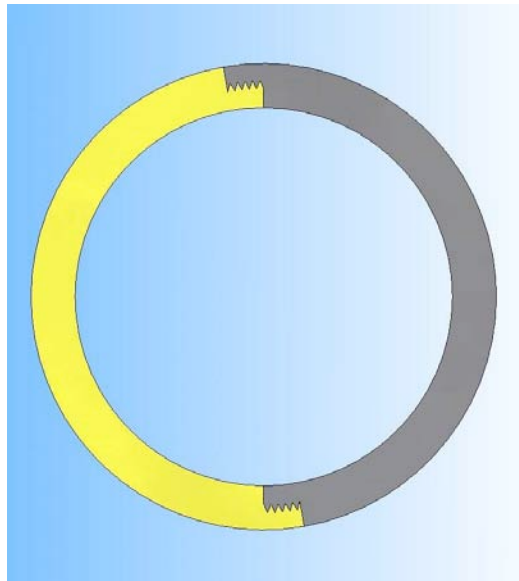
**Figure 21: Overlapping half-wrap patch design concept**

- d. **Overlapping Half-Wrap Patch:** a broad category of patches in which two half section patches were placed on opposite sides of the pipe and overlapped on both ends to provide support for the hoop stress (Figure 21). Several potential configurations were investigated:

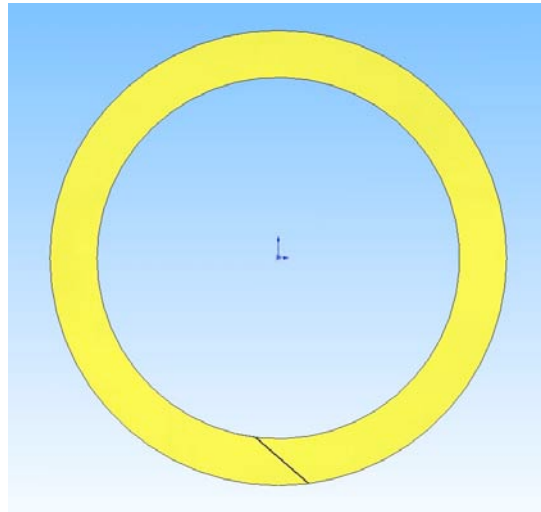
- e. **Overlapping Full-Wrap Patch:** a hybrid of the above concepts in which a single full-wrap patch was placed around the pipe and overlapped on the ends (Figure 22). A full-wrap patch substrate was pre-formed to fit inside the open jaws of the repair tool (see Figure 23). Once the tool was placed over

**Figure 22: Overlapping full-wrap patch design concept**

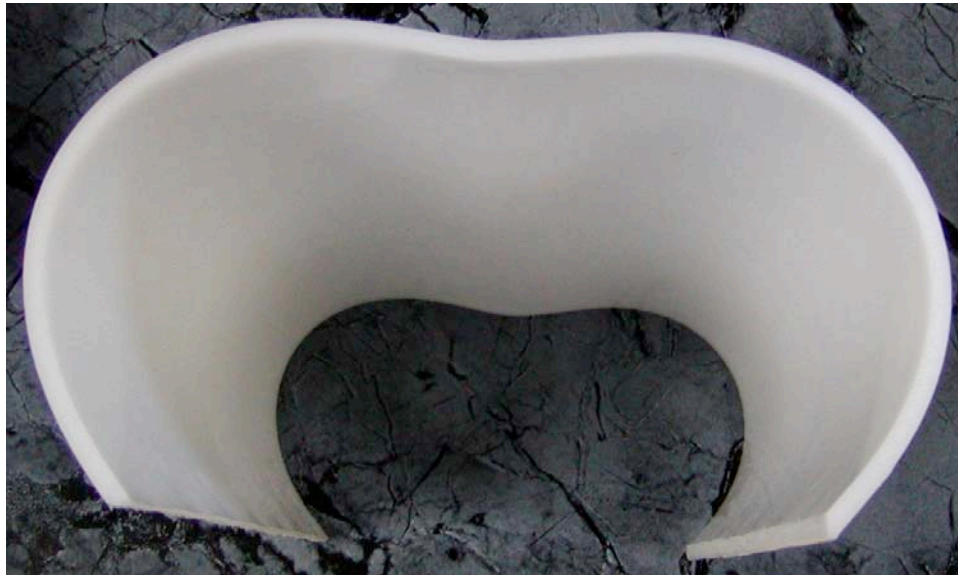
the pipe, the patch assembly was molded to tightly wrap around the pipe and overlap at the tapered joint.

**Figure 23: Preformed overlapping full-wrap patch**

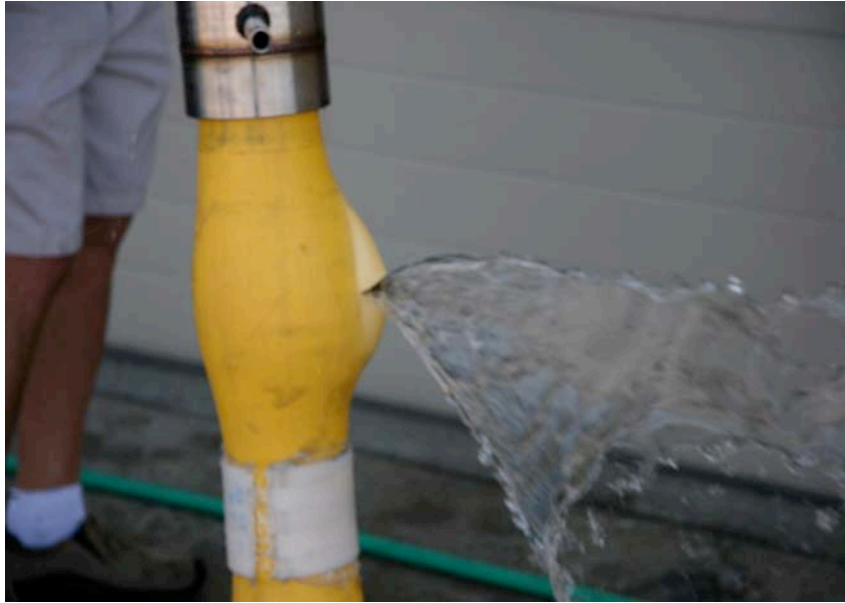
Pressure tests were performed on repaired 4-inch MDPE pipe samples obtained during the test tool performance tests in Task 4.4 to determine how well the PE adhesive, PE gel and PE gel film patches adhered to the pipe surface. The initial pressure tests conducted were quick burst tests performed by raising the hydrostatic

pressure in the patched pipe to 600 psi over a short time period (1-5 min) and held until the repaired pipe failed (Figure 24).

**Figure 24: Successful bond of PE gel patch to 4" MDPE pipe at 600 psi during quick burst testing**

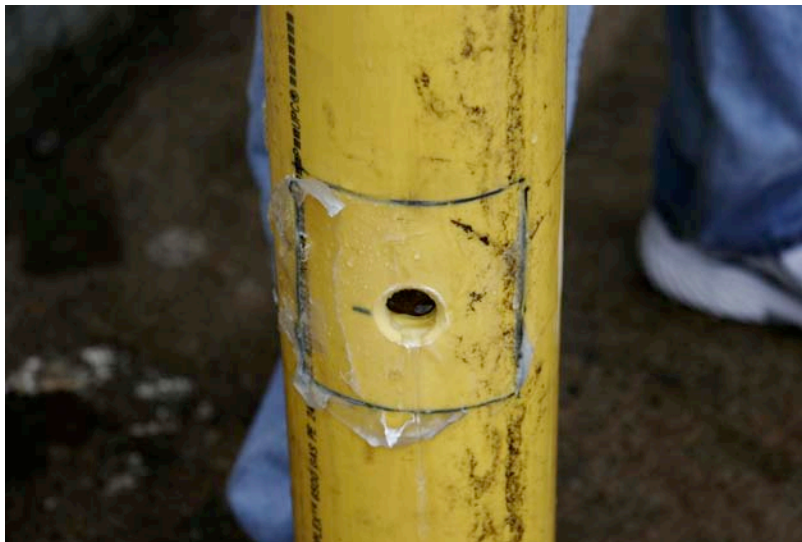
**Figure 25: Failure of adhesive patch during quick burst testing at 450 psi**

All the quick burst tests performed on the repaired PE pipe samples using DP8010 commercial adhesive patches resulted in patch bond failures between 250 and 450 psi (Figure 25). The PE gel and PE gel film patches, however, resulted in many

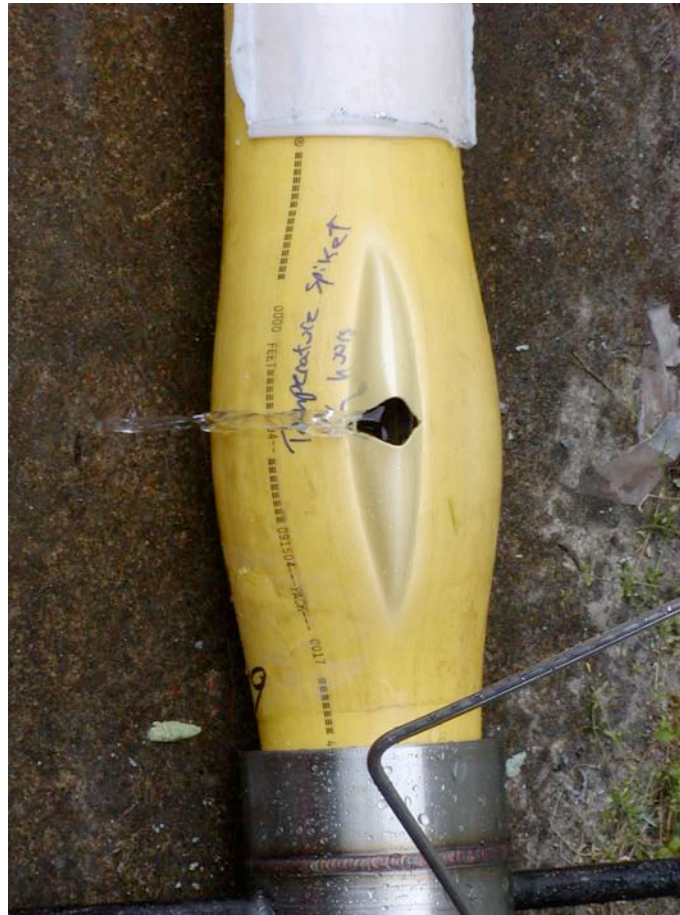
successful quick burst tests where the pipe failed at locations away from the patch (Figure 26).

**Figure 26: Quick burst test shows pipe failure below PE gel film patch – Indicative of successful bonding**

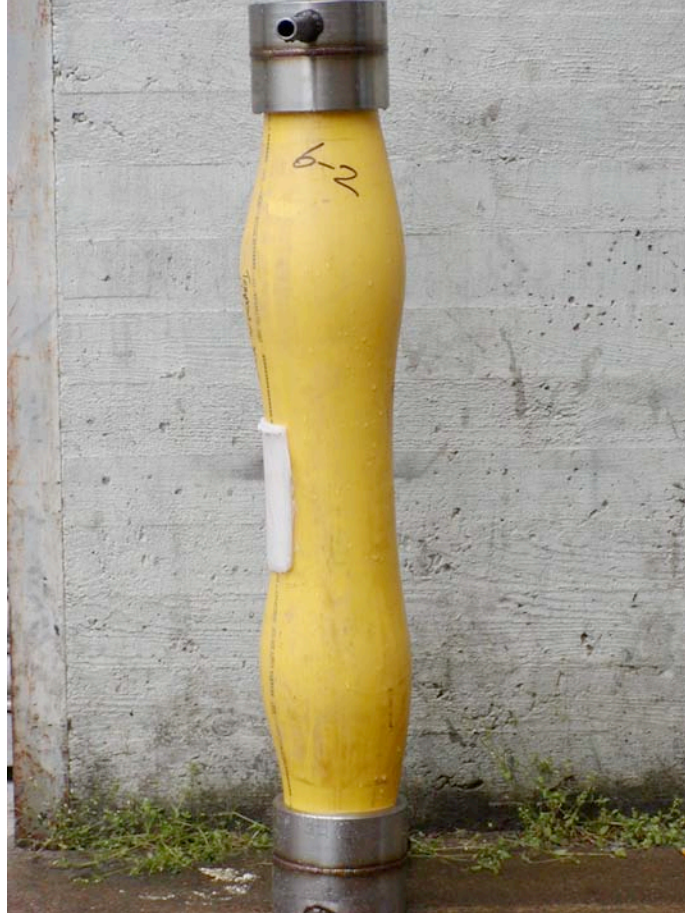
**Figure 27: Pipe sample repaired with half patch showing hoop stress reinforcement**

During initial quick burst tests, it was observed that the pipe seemed to be reinforced for hoop stress in the vicinity of the patch, even if only a half patch was applied (Figure 27).

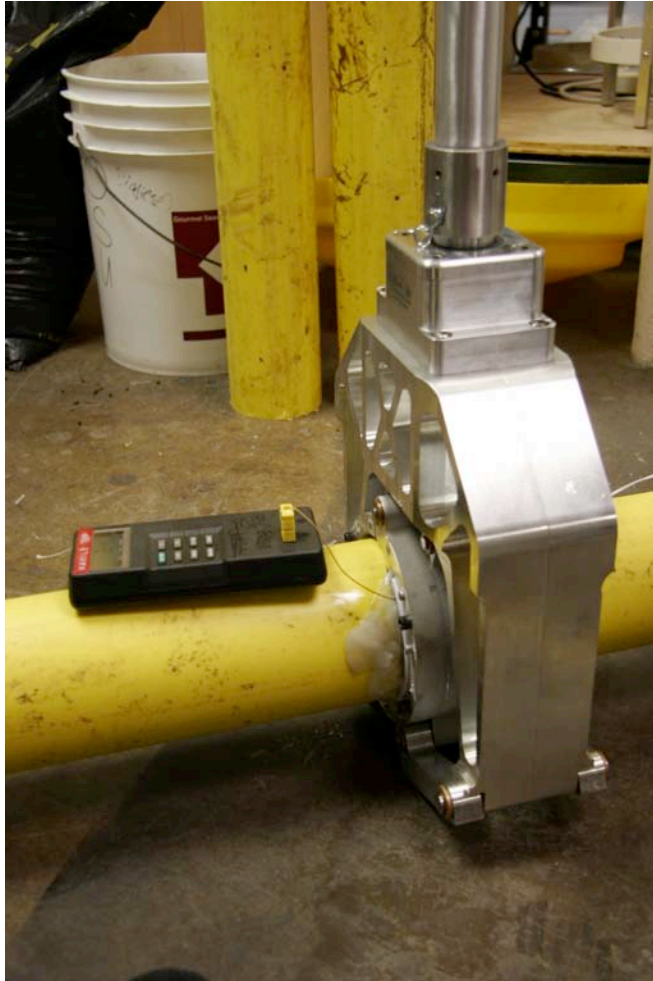
***Figure 28: Overlapping full-wrap patch applied to 4" MDPE pipe during demonstration for Northwest Natural***

At demonstrations performed for Northwest Natural Gas field crews in Portland, Oregon on February 25, 2005 (Figures 28 & 29), a thermo-chemical PE gel film repair patch (developed in Task 4.1) was applied over a 1-inch diameter hole drilled into the wall of one 4 ft section of 4-inch IPS (SDR 11.5) MDPE pipe pressurized to 45 psig. The repair patch was applied using the test tool developed during Phase 1. The repair patch successfully bonded to the pipe under pressure. Subsequently, the repaired pipe sample was sent to OSU for quick burst testing as reported in Subtask 5.1. The test tool was also successfully demonstrated to DOE/NETL project managers at Timberline Tool facilities in Kalispell, Montana on July 13-14, 2005 (Figures 30 & 31).

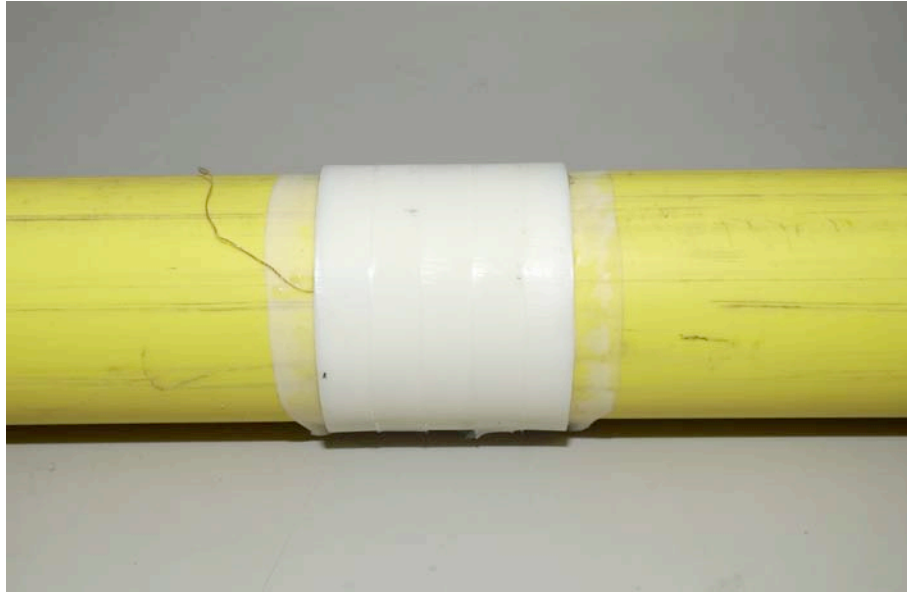
***Figure 29: Completed bonding of overlapping full-wrap patch on 4" MDPE pipe***

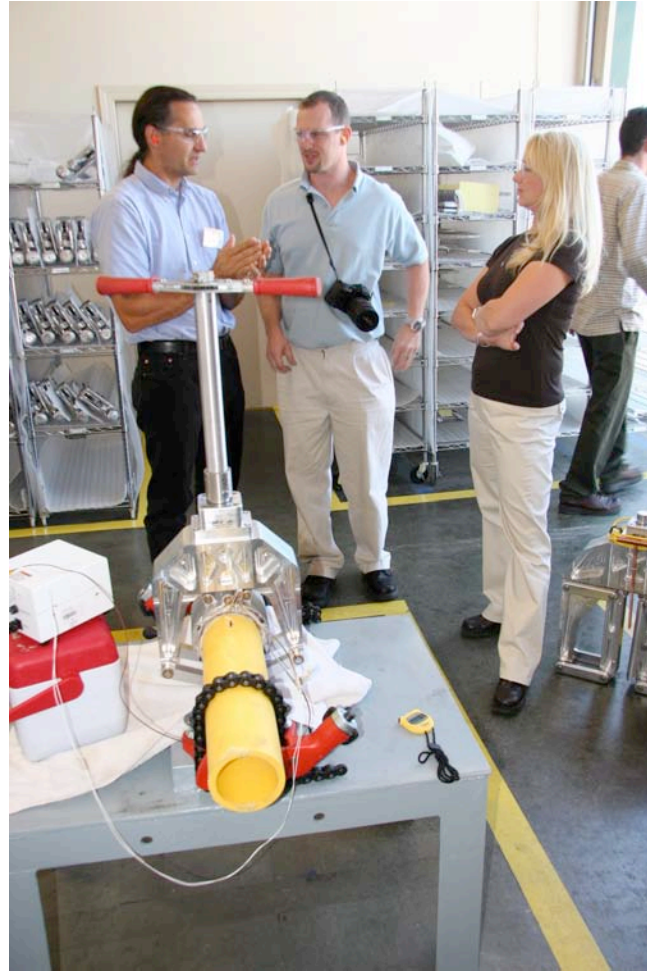
***Figure 30: Test tool and PE gel film patch repair process successfully demonstrated to DOE/NETL project managers at Timberline Tool facilities***

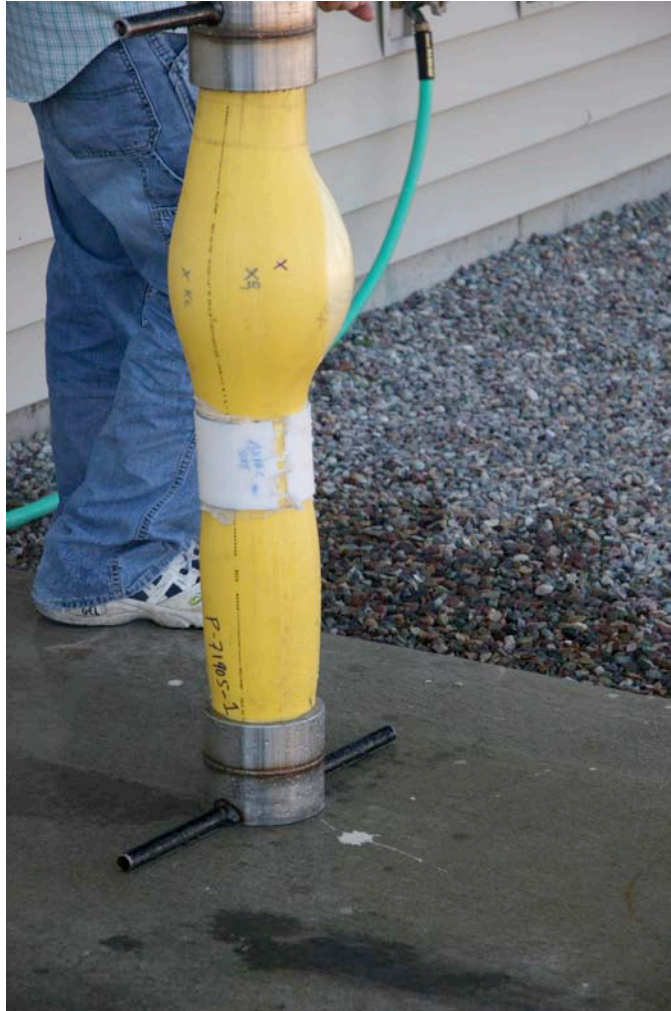
**Figure 31: Quick burst test for DOE/NETL demonstrates successful bonding of PE gel film patch on 4-inch MDPE pipe**

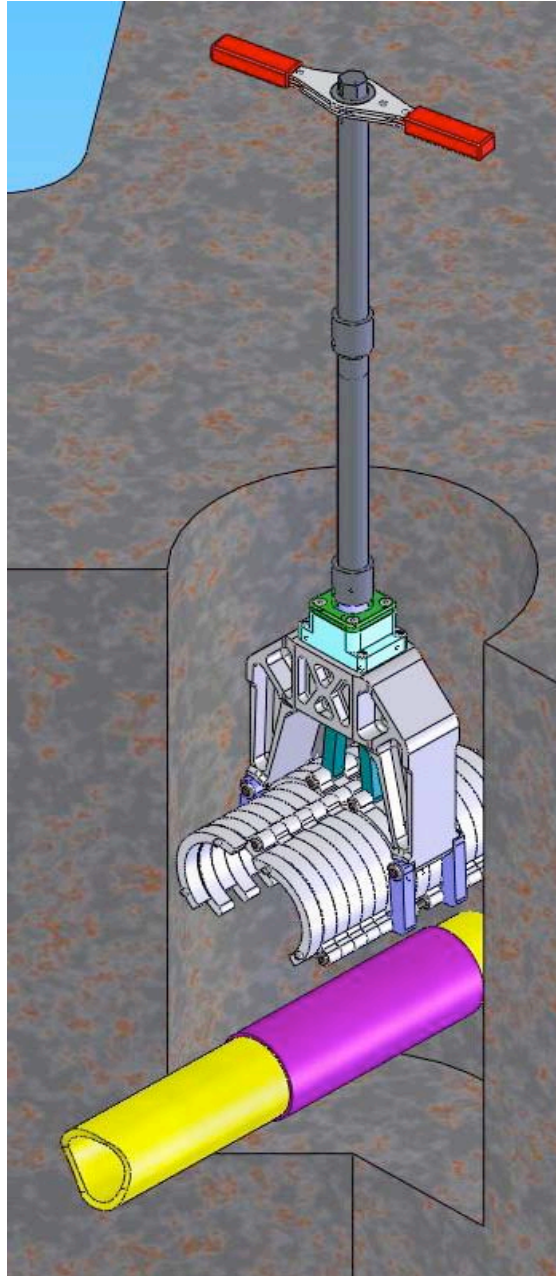
**Figure 32: Engineer prototype design shown with 12-inch jaws**

- The bearing and lead screw were redesigned to reduce the amount of stress exerted on the other components of the tool.
- The curved jaws were redesigned to eliminate flex in the jaw components.

- The jaw components were redesigned to cover a section of pipe 12 inches long in order to repair the majority of damaged pipe (small nicks as well as large gouges), (Figure 32).
- The internal cartridge heaters were redesigned to accommodate the extension of the jaws.

The preferred design concept of the engineer prototype was 3-D modeled and a prototype was constructed of 6061 T6 aluminum. A series of functionality tests were performed to validate the design changes detailed above. The engineer prototype

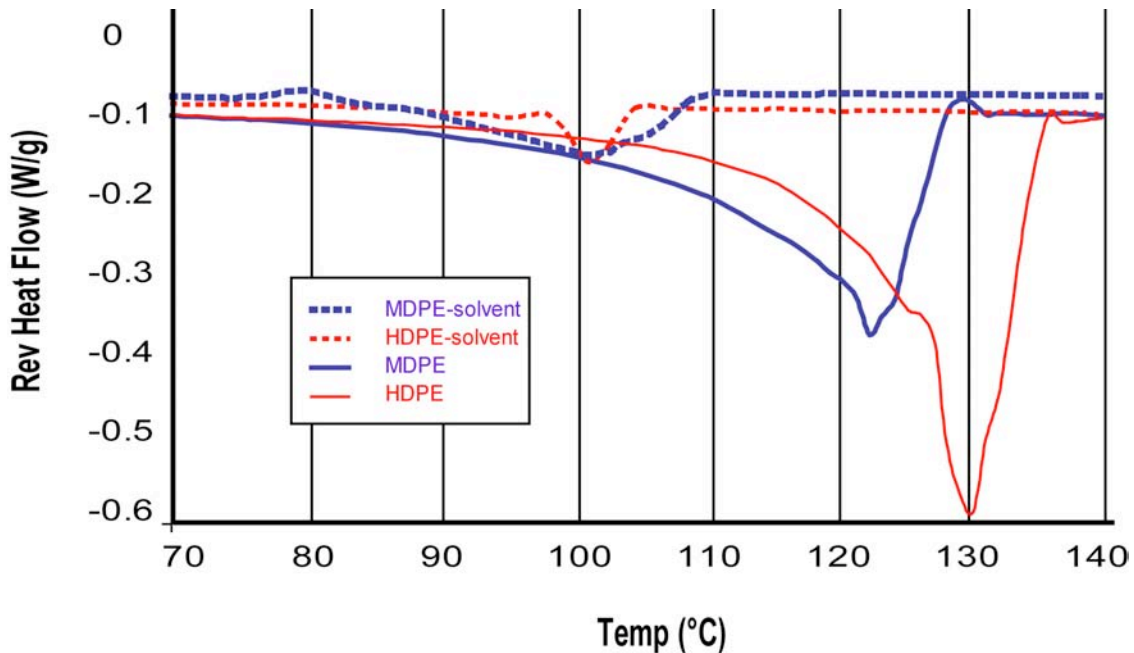
**Figure 33: Differential scanning calorimetry curves of virgin PE vs. PE with solvent shows the effect of solvent on lowering the melting point of PE**

Differential Scanning Calorimetry (DSC) of PE, in the presence of the solvent, showed an effective lowering of the melting point of both MDPE and HDPE (Figure 33). Lowering the melting point allowed for fusion welding to take place at the substrate-film-substrate interface without significantly diminishing the overall strength of the bulk of the substrate polymers during the bonding process. PE gel films reached their peak strength with a cure temperature of 110°-120°C. It was vital, however, to have enough solvent in the PE gel film (or PE gel) to allow the solvent to affect both substrate surfaces during the cure process.

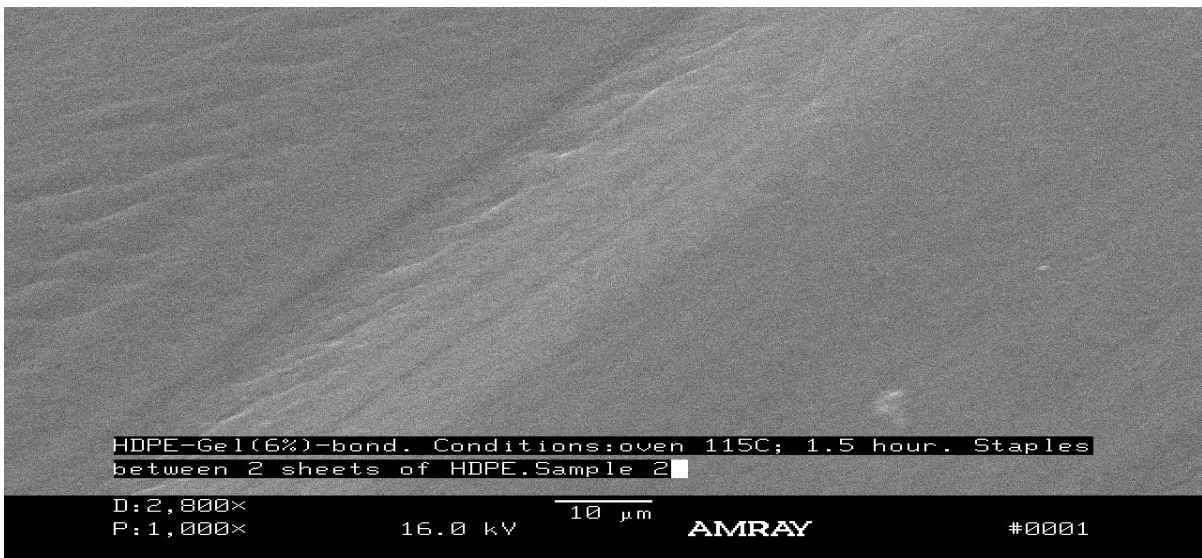
**Figure 34: SEM micrograph showing uniform PE bond interface**

Another indication that the bonding mechanism was successful is shown by a SEM micrograph of the bonded area (Figure 34). From this SEM micrograph, a uniform area was seen with no defined layers. This uniform bond area indicated a seamless fusion of the two substrates.

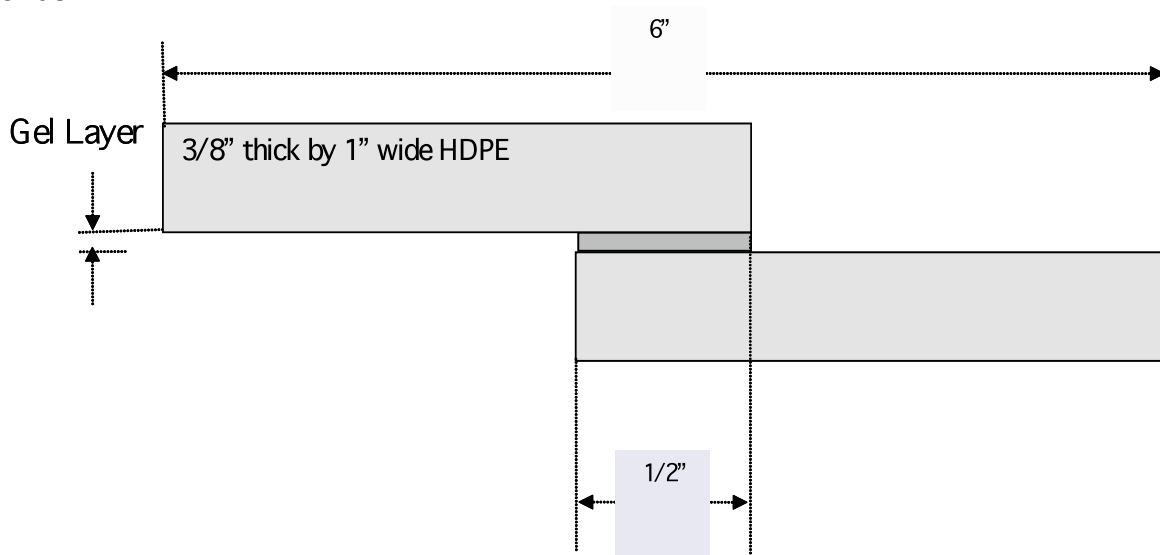
**Figure 35: Diagram of lap shear sample design**

Lap shear samples were designed to test the bond strength of the PE gel or PE gel film bonds (Figure 35). The lap shear samples were then pulled at a rate of 1-inch per minute to test the strength of the bonds (early work samples were pulled at 1/2-inch per minute). The major variables affecting bond strength were time, temperature, and pressure. For these tests, the platen pressure was maintained at 20 psi. The polymer fusion process required just enough pressure to keep the substrate-film-substrate in firm contact since lower pressures resulted in air gaps, and higher pressures squeezed out the gel layer, both of which resulted in inferior bonds.

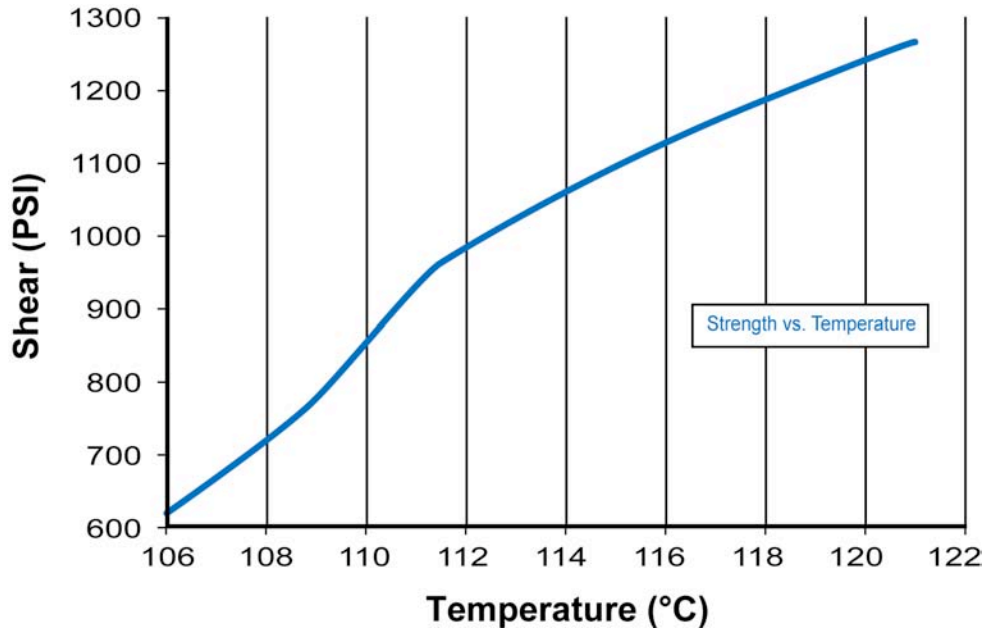
**Figure 36: Graph of bond strength as a function of bonding temperature**

Temperature experiments were performed with a total cure time of 90 min. For these tests, the lap shear samples were produced at a temperature range of 106°-120°C. The curve of these points is shown below in Figure 36. As expected, in this temperature range, the strength of the bond increased almost linearly as the temperature increased.

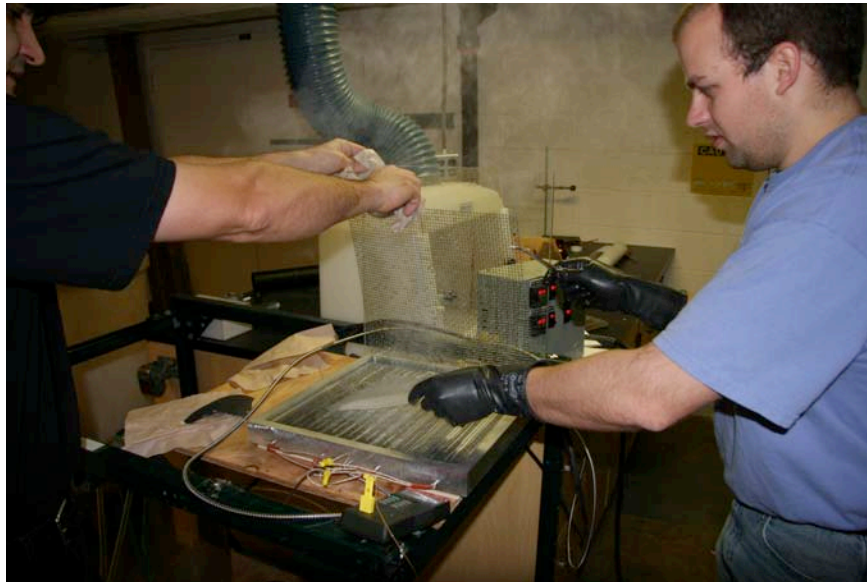
**Figure 37: Swelling process used to fabricate a large PE gel film patch**

The large PE gel film patches were made by swelling (Figure 37) 8" X 8" UHMWPE films in solvent until they were larger (Figure 38) than a 14" X 14" swollen film. This PE gel film was then placed between a pre-formed sheet of HDPE substrate (the patch) and a very thin sheet of HDPE (0.001"-0.003") (the packaging material) in a sandwich-like configuration (Figure 39).
