# **Development of a Remote External Repair Tool for Damaged or Defective Polyethylene (PE) Pipe**

## **Final Report**

February 2007

Submitted by:  
Timberline Tool  
2594 Montana Highway 35  
Kalispell, MT 59901

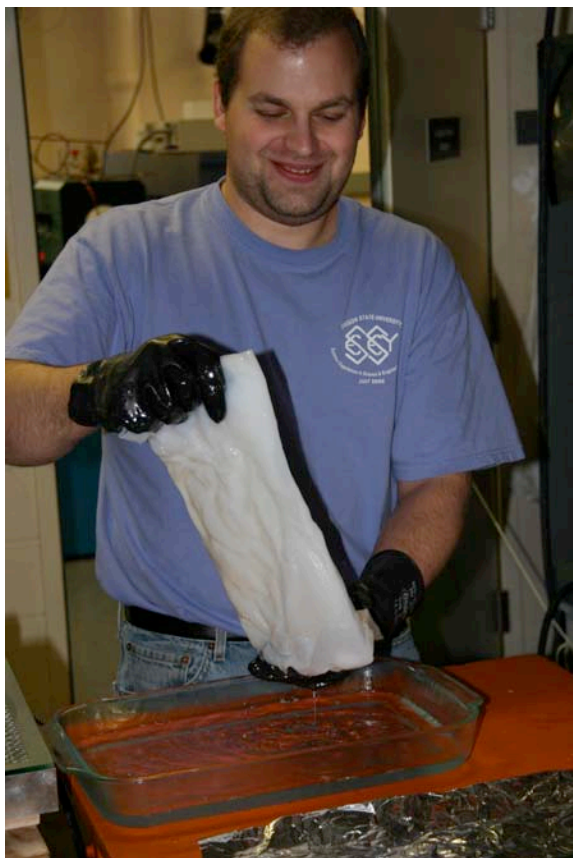
**Figure 38: Photo of the final large PE gel film patch after the swelling process**

The large PE gel film patches were made by swelling (Figure 37) 8" X 8" UHMWPE films in solvent until they were larger (Figure 38) than a 14" X 14" swollen film. This PE gel film was then placed between a pre-formed sheet of HDPE substrate (the patch) and a very thin sheet of HDPE (0.001"-0.003") (the packaging material) in a sandwich-like configuration (Figure 39).

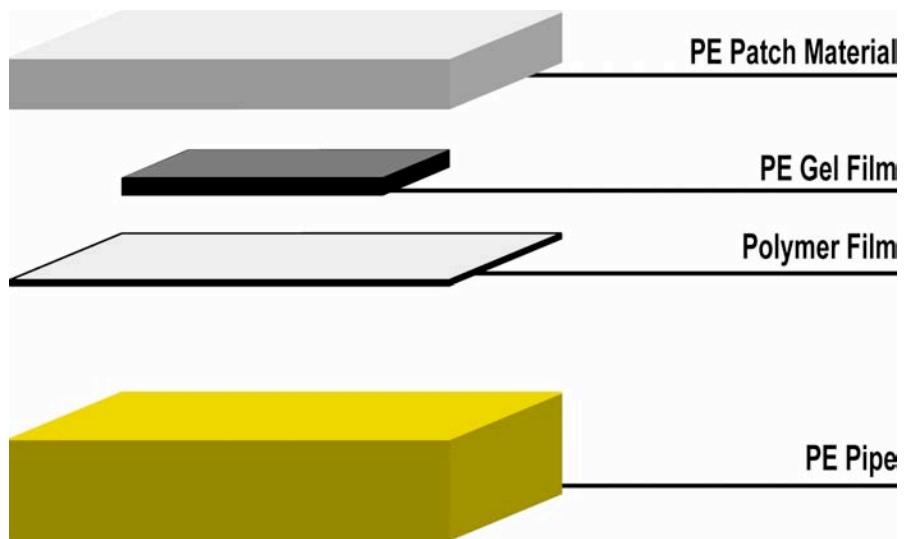
**Figure 39: Diagram of PE gel film patch design**

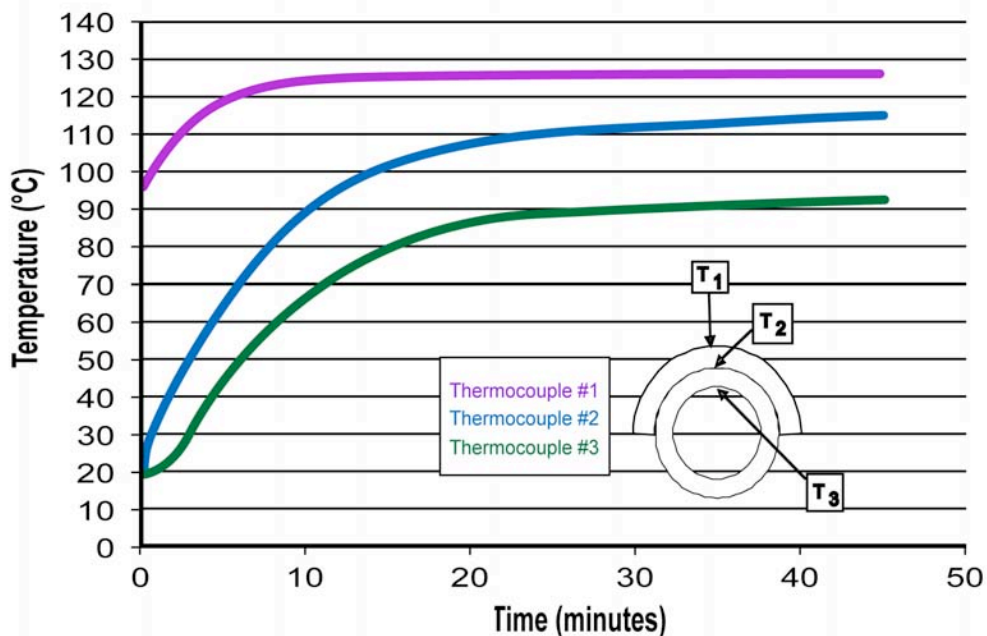
**Figure 40: Temperature vs. heating time for 125°C platen temperature**

One of the big hurdles to move from the platen based small lap shear samples to the large pipe patch application was the time required to reach temperature at the interface. The small lap shear samples used the double-heated method whereby both platens of the press were heated to 117°C and resulted in a satisfactory bond in approximately 10-15 minutes. However, heating and maintaining temperature on an actual pipe sample was significantly different due to the one-sided heating and the additional heat losses. For this reason, heating profiles were developed for the engineer prototype tool (Figure 40). These profiles showed that, starting at a temperature of 30°C, approximately 20 minutes was required for the interface temperature to reach the desired temperature. It also illustrated that the pipe being patched remained well below its natural melting point. As with the lap shears, the pipe patch interface required a minimum of 30-60 minutes at the desired temperature to achieve good bond strength. Therefore, a total cure time of 90 minutes was used when patching pipes with the engineer prototype repair tool. This allowed the bond interface polymers enough time to fuse.

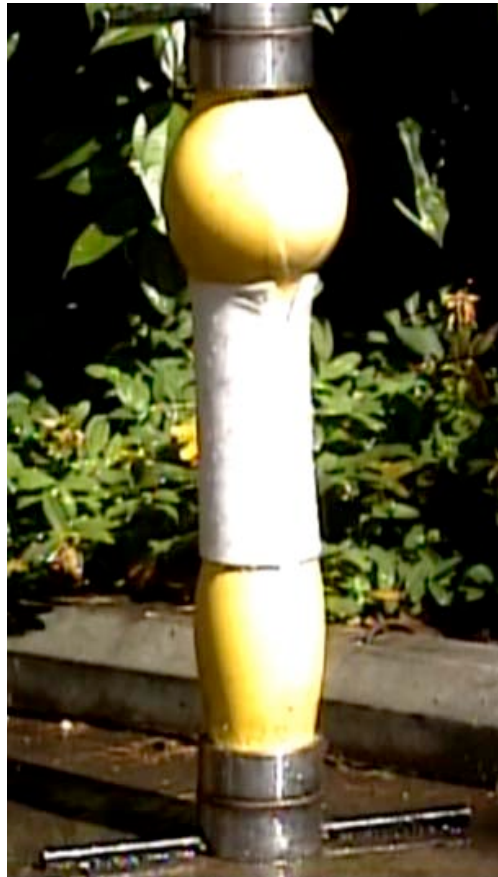
***Figure 41: Quick burst test with overlapping full-wrap gel film patch shows successful bond at 500 psi***

The technical objective of this subtask was to determine the overall performance of the HDPE repair patch (full wrap-overlapping PE gel film) using quick-burst testing to 600 psi, sustained pressure testing to 200 psi and stress-rupture regression on PE pipe samples repaired by the engineer prototype in Phase 2. Tests were conducted to determine the overall performance of the repair patch (including bonding) with ASTM D1599 quick-burst tests (Figures 41 & 42) at 23°C and 80°C; ASTM D1598 sustained pressure tests at 23°C and 80°C; and 23°C stress-rupture regression per ASTM D2837. Results of these tests showed successful bonding of a full wrap patch. Furthermore, a closed system full wrap-overlapping PE gel film patched pipe was held at room temperature and 200 psi for greater than 5 months without any loss in pressure (Figure 43).

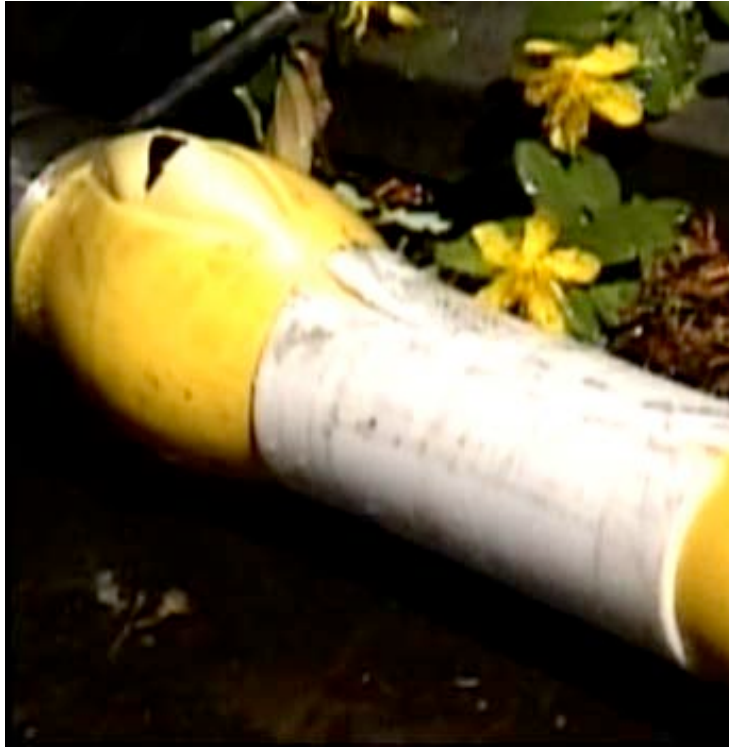
**Figure 42: Quick burst test with overlapping full-wrap gel film patch shows successful bond & pipe failure below the patch at 600 psi**

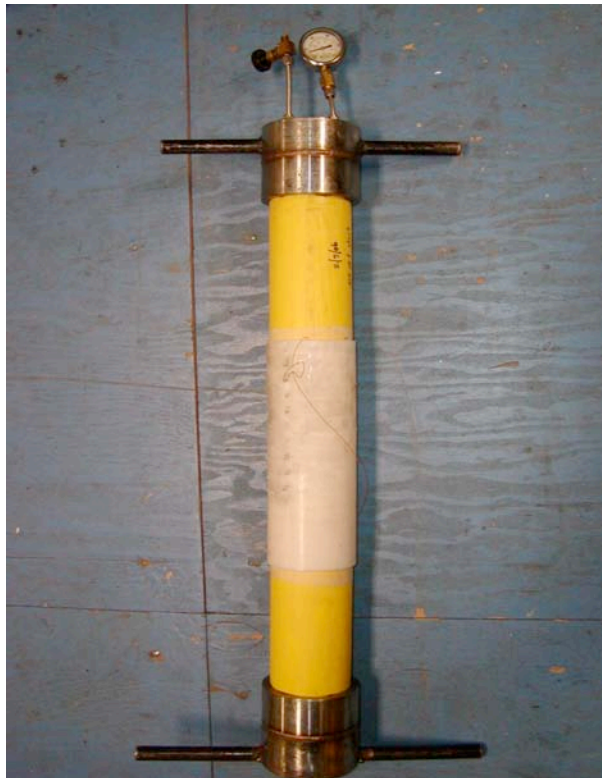
**Figure 43: Closed system overlapping full-wrap gel film patch held at  $R^\circ$  & 200 psi for > 5 months without any loss in pressure**

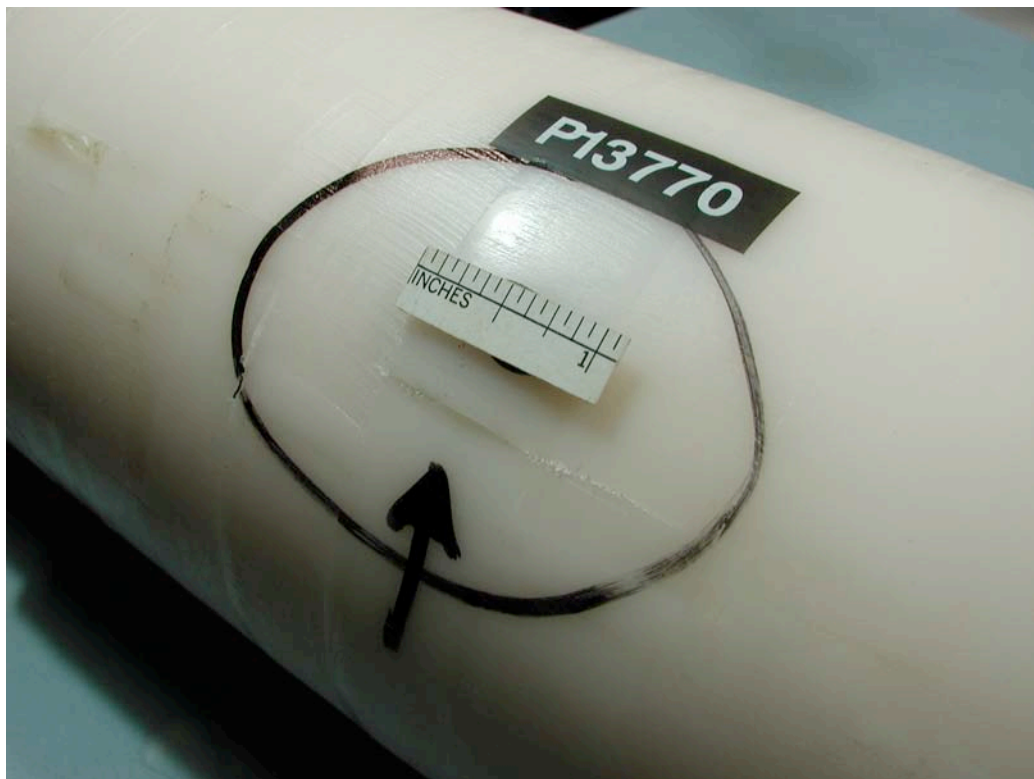
**Figure 44: Photo of HDPE patch material failure at the 25-year mark during accelerated age testing**

Initial accelerated age testing of repaired pipe sections showed that the applied 3/16" thick HDPE patches developed a small crack in the high-stress areas surrounding the patched hole within the first 48 hours of hot water testing (Figure 44), which indicates the patch material has an approximate 25-year lifespan. Based on these results, the repair patch material will need to be stronger for a achieve a satisfactory 50 year patch system. The use of very high molecular weight PE (VHMWPE) or UHMWPE for the patch material is being investigated.

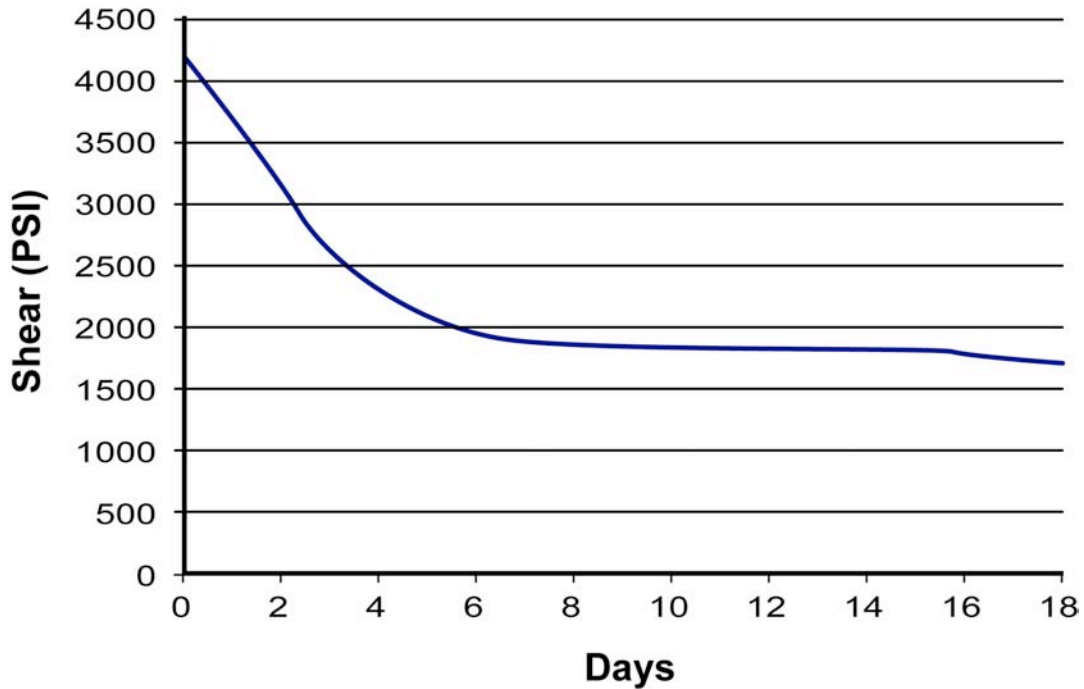
**Figure 45: Graph of HDPE patch material strength loss vs. time (days)**

This HDPE repair patch substrate failure was of a brittle nature that was not seen in the room temperature lap shear tests in Task 8.2. In order to find the mechanism associated with these failures, lap shear samples were thermally “aged” in days and then pulled to find what effect thermal aging had on the bonds and substrates. These tests showed that the adhesive bond interfaces retained the majority of their strength, while the HDPE substrates themselves became embrittled and weakened. Figure 45 shows this weakening trend for HDPE as a function of time in 80°C water. The HDPE lost more than half of its strength within 5-6 days at these conditions.

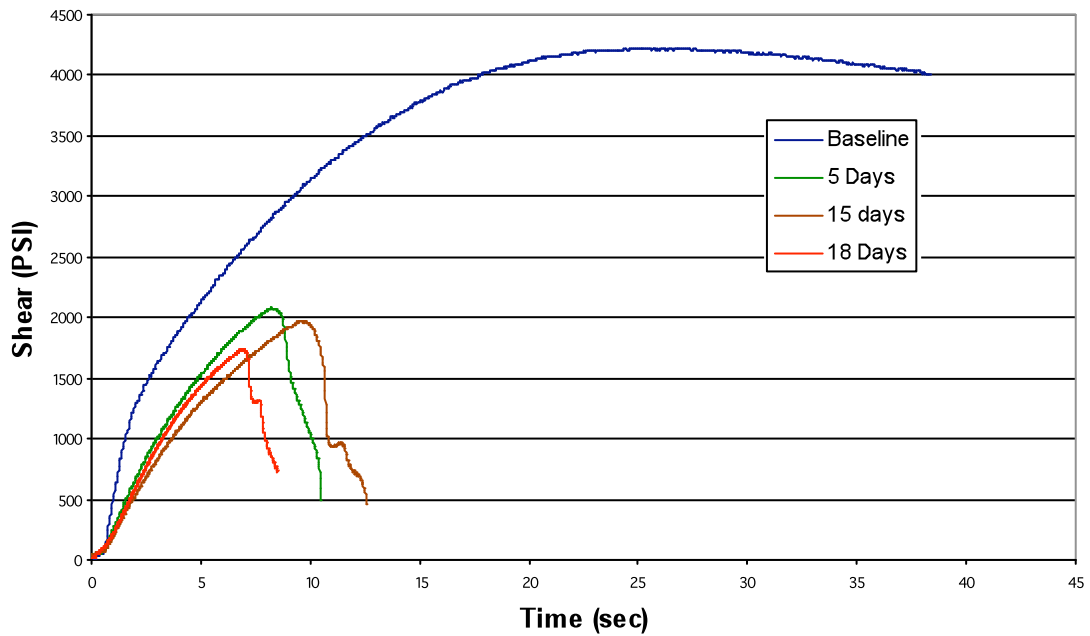
**Figure 46: Graph of HDPE patch material strength loss at 5, 15, and 18 days**

The same information is presented in Figure 46, where the average pull data (shear) was graphed for 5, 15, and 18 days, compared to non-aged samples (baseline).

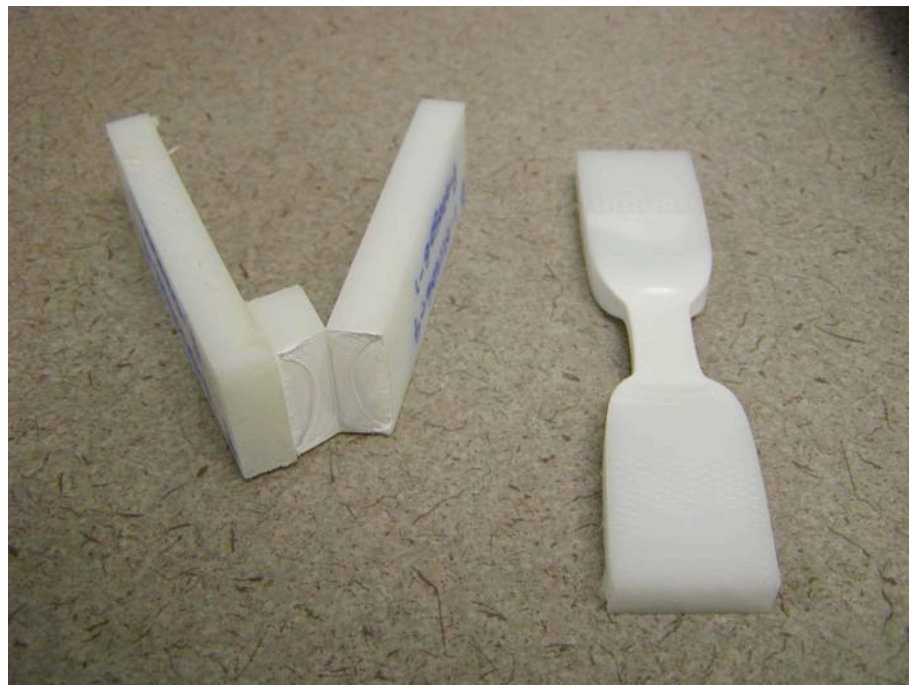
**Figure 47: Broken embrittled HDPE material (left) compared to typical necking in HDPE control sample (right)**

Figure 47 compares samples of broken embrittled HDPE lapshear samples that were subjected to solvent and the typical necking seen in the control HDPE sample of the same material.

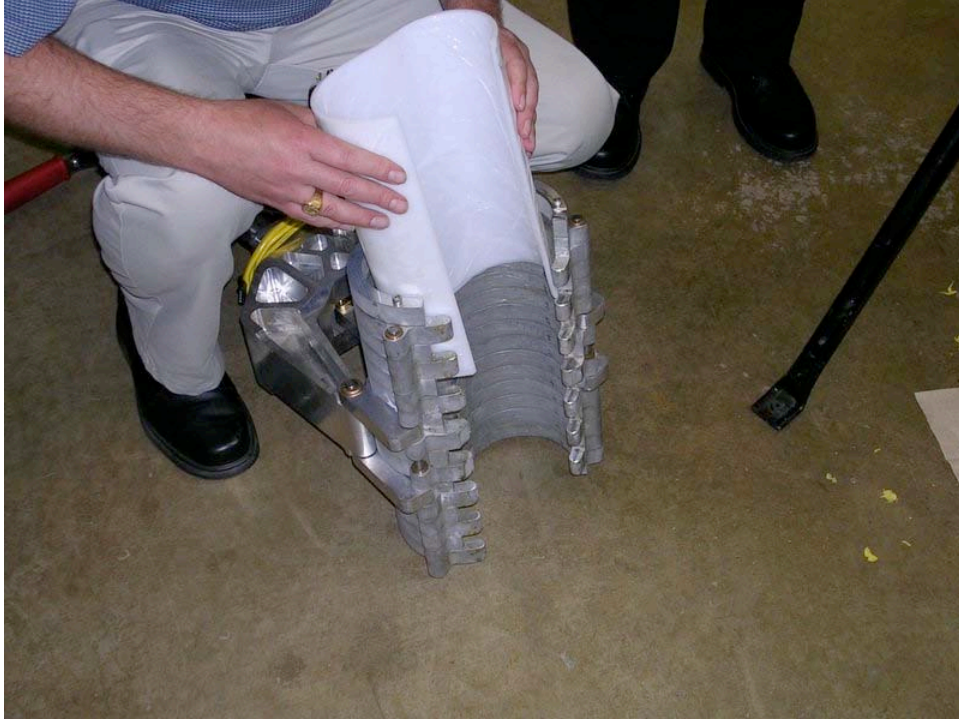
**Figure 48: PE gel film repair patch being loaded into the engineer prototype at Nicor Gas demonstration in Naperville, IL**

At demonstrations performed for Nicor Gas in Naperville, Illinois on April 19, 2006, a HDPE PE gel film repair patch was applied over a 1-inch hole drilled into the wall of one 4 ft section of 4-inch IPS SDR 11.5 MDPE pipe. A similar repair patch was also applied over a second 4 ft section of pipe with a series of holes drilled through the pipe wall in a pattern that approximated a 2"x 4" hole. Both sections of pipe were pressurized to 65 psi during application. Both repair patches successfully bonded the patch to the pipe. These sections were subsequently subjected to long term testing according to ASTM D1563 at Nicor's facilities. Within 48 hours, the patch material (HDPE) developed a small crack directly over the hole in both pipe samples. However, the bond between the patch and pipe was not affected. These findings were consistent with prior work at OSU (see Figures 48, 49, and 50).

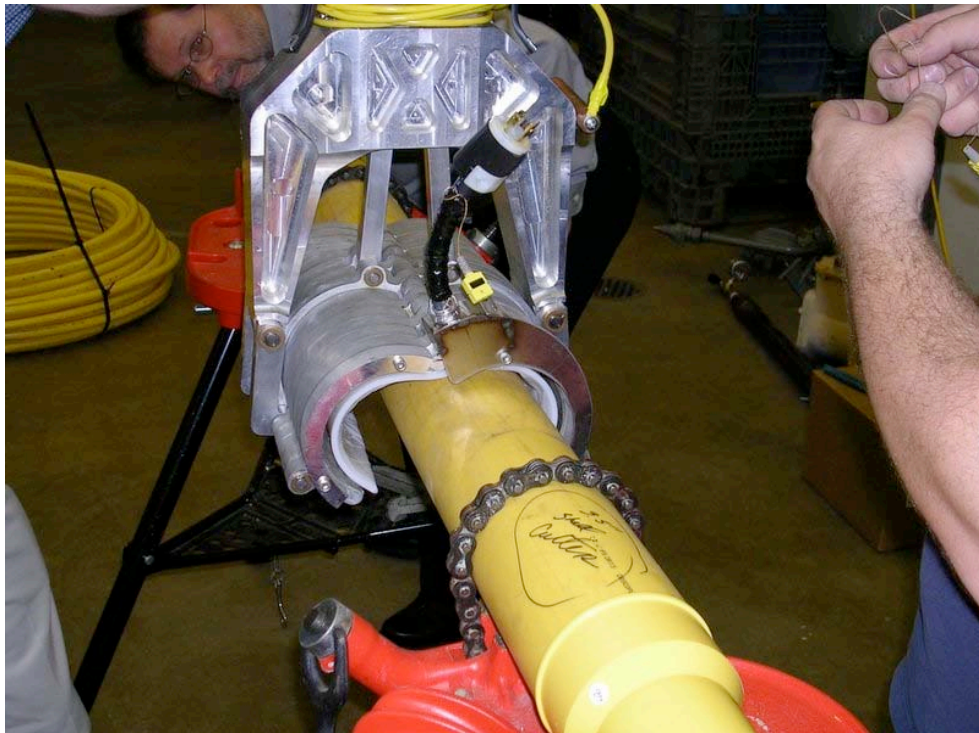
**Figure 49: Engineer prototype with PE gel film repair patch being applied to damaged 4-inch MDPE pipe**

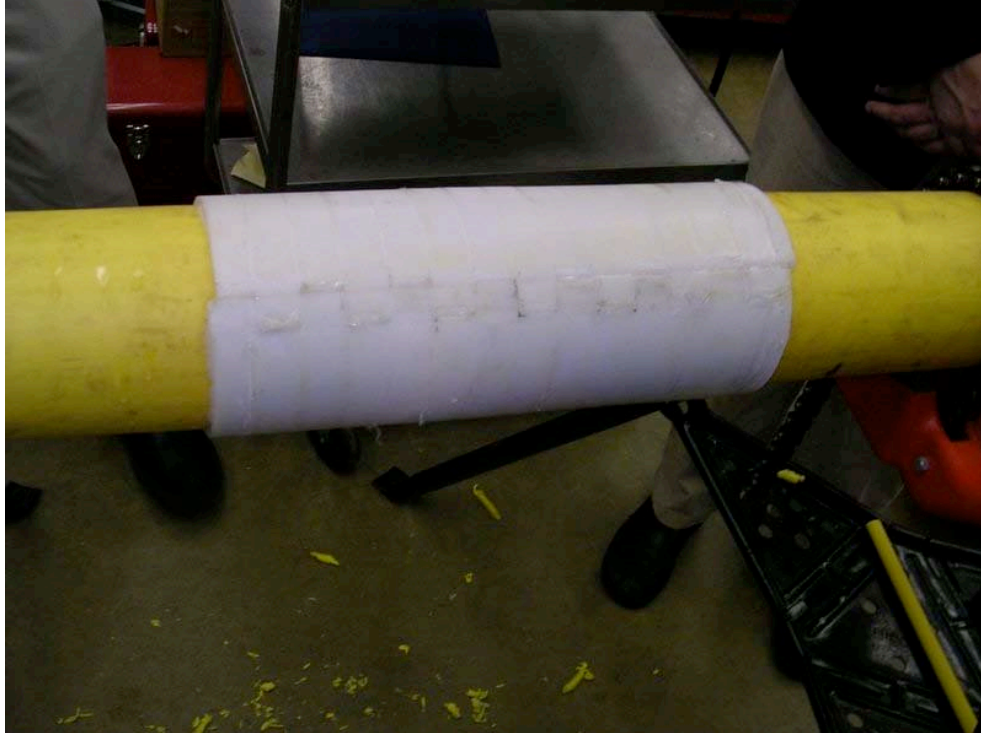
**Figure 50: PE gel film patch successfully repaired a damaged 4-inch MDPE pipe**

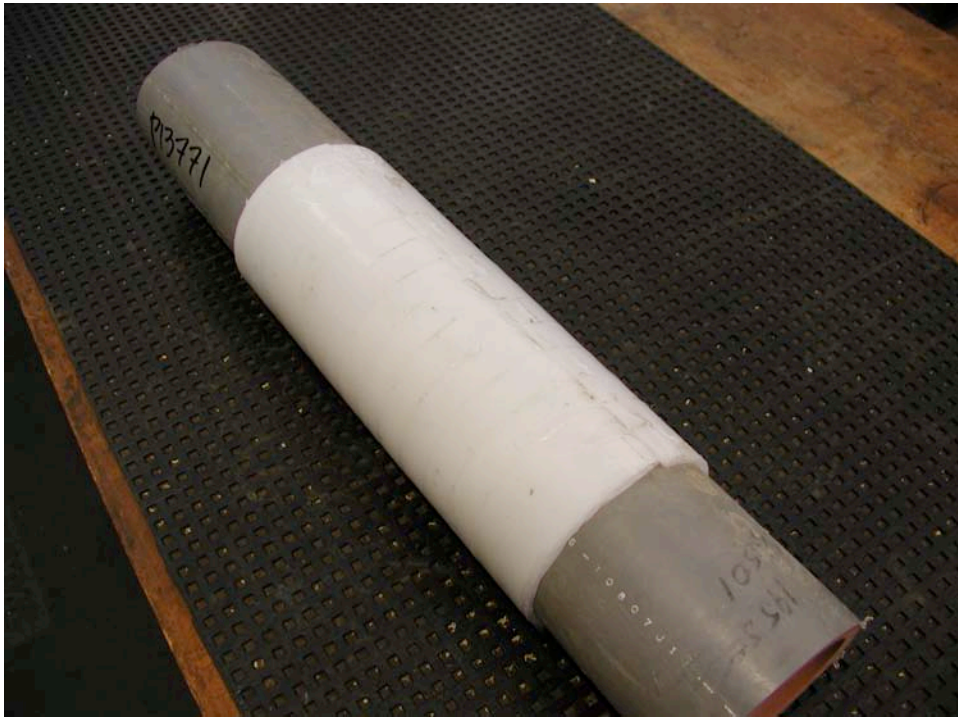
**Figure 51: Overlapping full-wrap PE gel film patch successfully bonded to oxidized 4" IPS Aldyl-A pipe during demonstration for Sempra Energy**

At demonstrations performed at Sempra Energy in Los Angeles, California on May 25, 2006, a HDPE substrate/ UHMWPE swollen PE gel film repair patch was applied over a 1-inch hole drilled into the wall of one 4 ft section of 4-inch IPS SDR 11.5 HDPE pipe. A second identical patch assembly was applied to an oxidized 4 ft section of 4-inch Aldyl-A pipe (Figure 51). This section of pipe had been buried in the ground for 25 years. The HDPE pipe was pressurized to 65 psig. The Aldyl-A pipe was not pressurized. Both repair patches successfully bonded to the pipe. The HDPE pipe section was subjected to 670 psi hoop stress (~107 psig) in 80° C water for 48 hours. As seen in prior tests at other gas companies, a small crack developed at the area of damage. However, the bond between the pipe and the patch was not

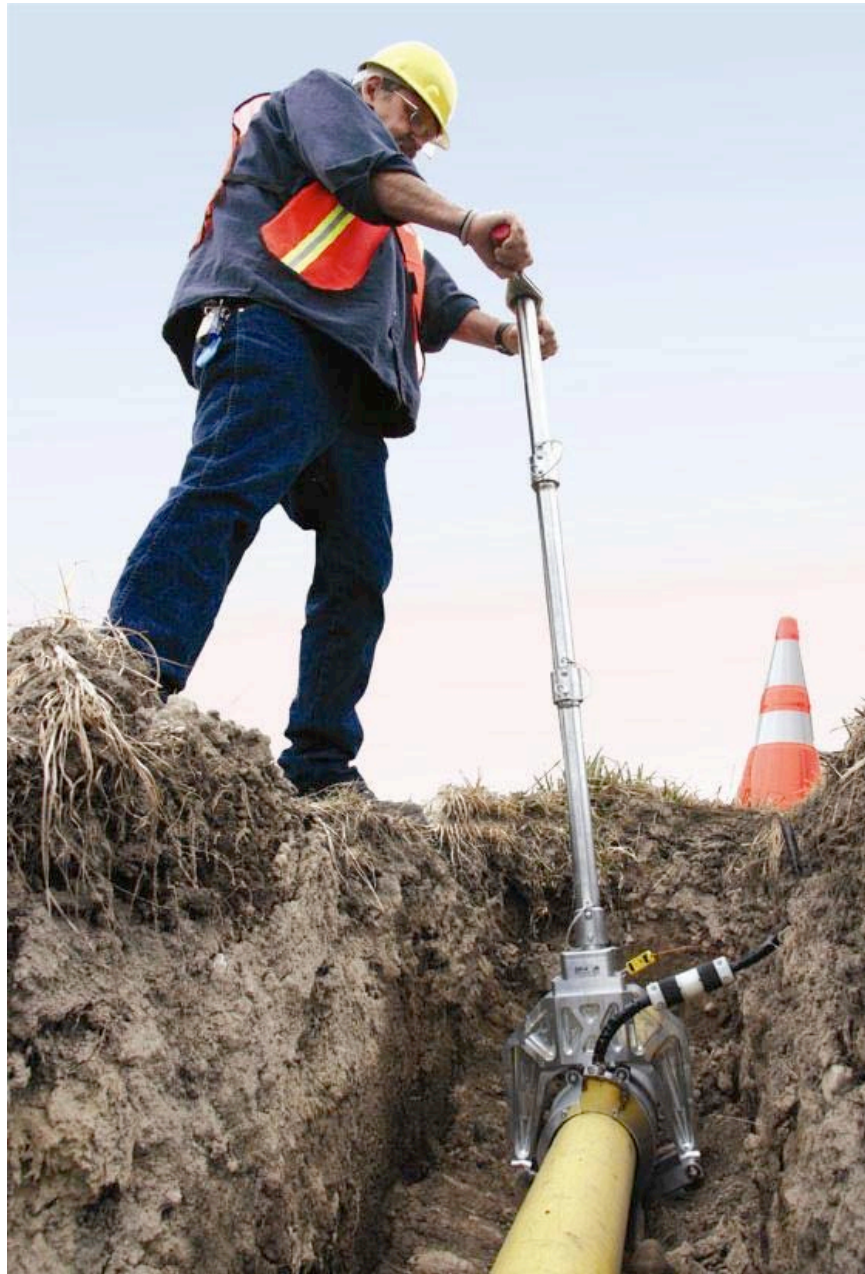
***Figure 52: Final engineer prototype applying a PE gel film patch on 4-inch MDPE pipe***

The design and performance of the engineer prototype (Figure 52) and the thermo-chemical process were successfully evaluated by the project team with critical input from the natural gas utility partners. The engineer prototype was evaluated against the design constraints as originally set forth in the proposal.

- Weigh less than 60 lbs.: The repair tool weighs less than 40 pounds.
- Requires only one person for operation: The repair tool is easily operable by one person.

- Meets physical requirement of ASTM F 1563-01: The repair tool meets the requirements of ASTM F1563-01. The tool applies the thermo-chemical patch that retains or improves pipe integrity and fully encompasses the circumference of the pipe.

- Applies a thermo-chemical patch that stops the flow of gas from the leak: The repair tool is able to stop the flow of gas immediately upon application, and applies sufficient pressure to the patch and pipe to maintain the seal.
